Gaps Between Strips in Hardwood Floors

COMMON COMPLAINTS

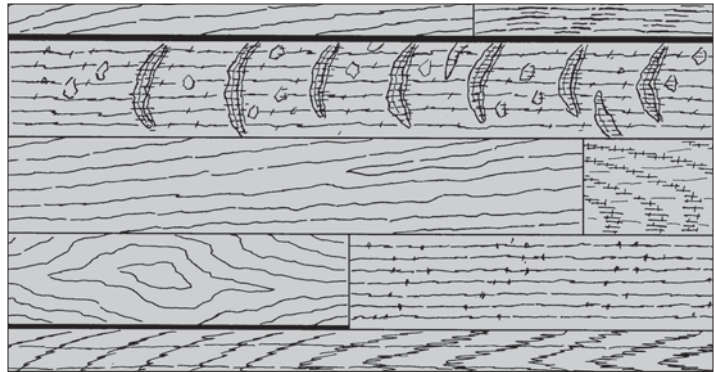
NORMAL GAPS

The term “normal gaps” can have various definitions depending on the width of the strips, whether boards or parquet patterns, the size of the room, and the severity and duration of the low outside temperatures and hence the intensity of the indoor heating.

Gaps between strips that occur seasonally and close during seasons associated with higher humidity or the non-heating season are considered normal gaps. Normal gaps may vary in width from “hairline” gaps (thickness of stationary) to more significant gaps (up to or greater than the thickness of a quarter) depending upon the size of the strips of flooring. The larger gaps are expected in geographical areas associated with an extended dry heating season, and warm, mild, humid summers that require little air conditioning, i.e. the Great Lakes or New England area.
